TROUT RUN DAM

National Dam Safety Program. Trout Run Dam (NDI-Pa.-481), Ohio River Basin, Trout Run, Westmoreland County, Pennsylvania. Phase I Inspection Report.

**PHASE I INSPECTION REPORT
NATIONAL DAM INSPECTION PROGRAM**

OCTOBER 1978

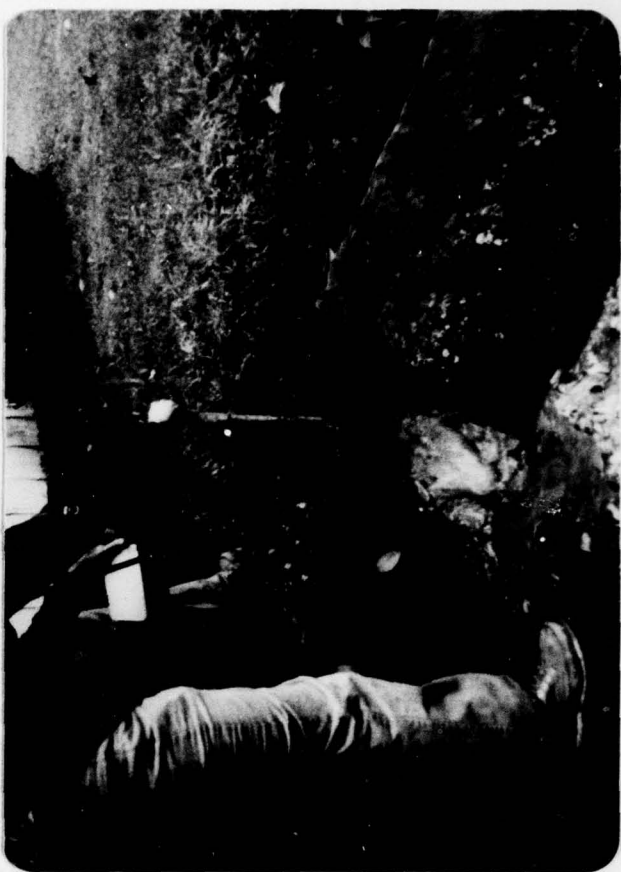
PHOTOGRAPH 8 Detailed view showing discharge from the 4-inch diameter cast iron pipe shown in the previous view. This discharge reportedly originated at a deep mine located above the embankment on the left abutment.

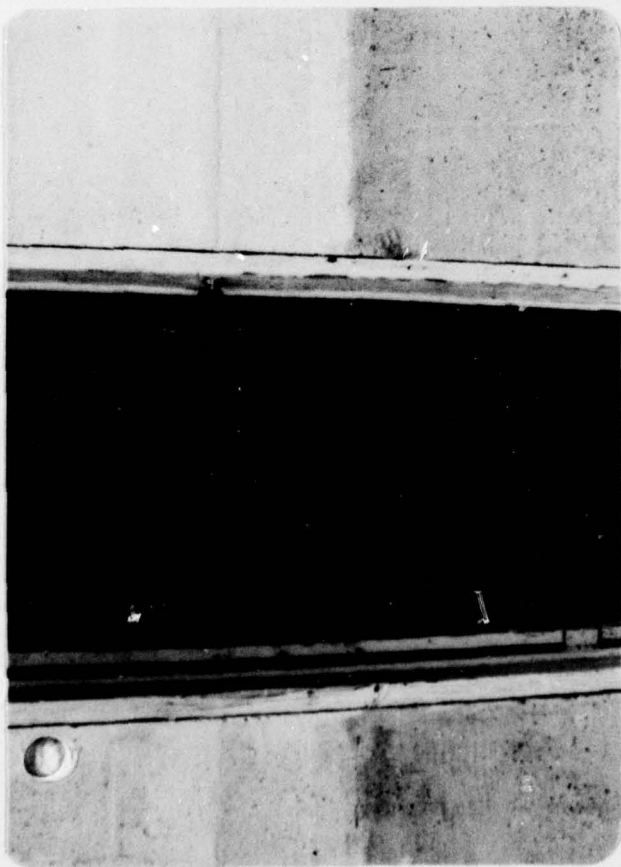
PHOTOGRAPH 5 View of the interior of the gate house.
